Above the Flood: Elevating Your Floodprone House

FEMA 347/ May 2000

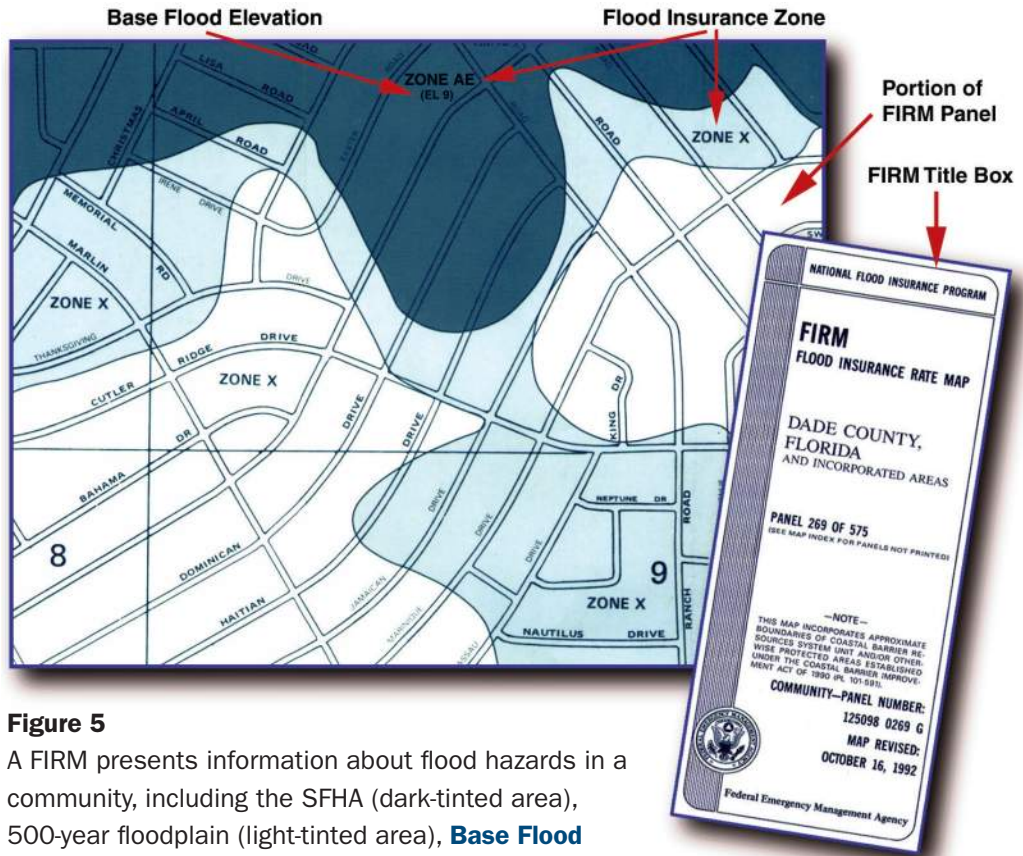
Figure 5
A FIRM presents information about flood hazards in a community, including the SFHA (dark-tinted area), 500-year floodplain (light-tinted area), **Base Flood Elevations**, (BFEs) (number in parentheses), and flood insurance zones (AE and X in this example).

Note that the SFHA in the example in Figure 5 is designated Zone AE. This zone is only one of several applied to SFHAs under the NFIP, including V, VE, V1-V30, A, AE, A1-A30, AO, and AH. These zones indicate differences in the types and severity of flood hazards in SFHAs. For the purposes of this publication, it is sufficient to focus on the basic differences between the two main types of SFHA zones—V zones and A zones. The distinction is important because regulatory requirements associated with V zones and A zones differ significantly. As explained later in this chapter, these requirements affect the types of building elevation techniques that may be used under the NFIP.

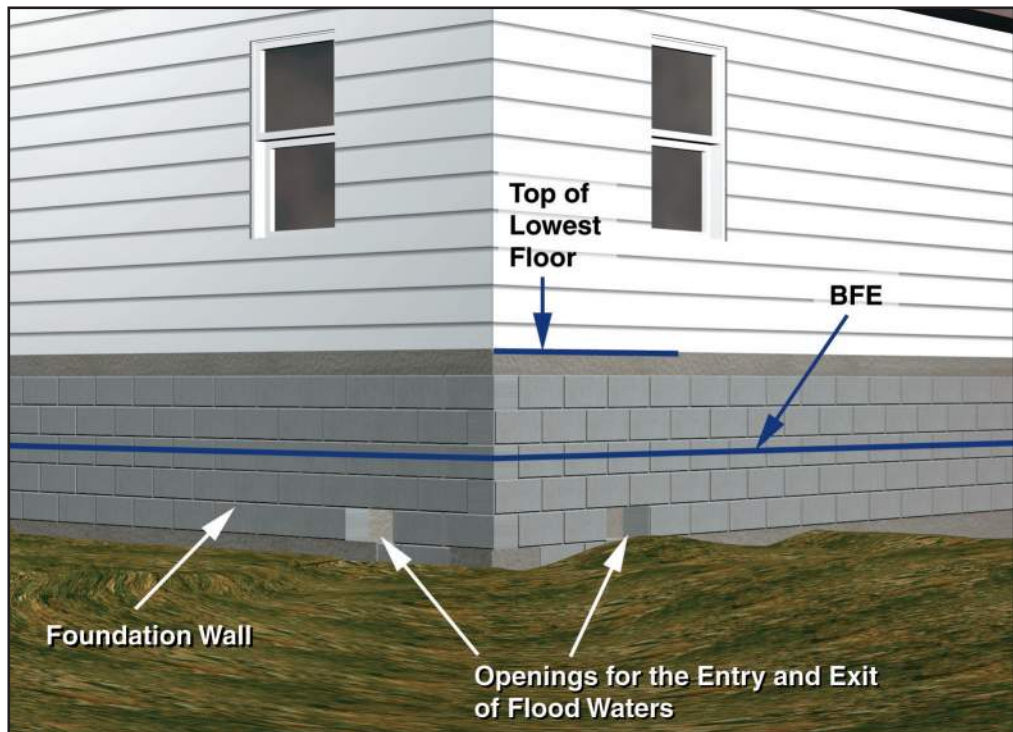
Figure 6
In a new, substantially improved, or substantially damaged building in an A zone, the elevation of the lowest floor must be at or above the BFE.

In A zones, where flood hazards are less severe, buildings may be elevated either on an open foundation or on continuous foundation walls below the BFE (Figure 6). Regardless of the type of foundation used, A-zone buildings must be elevated so that the **lowest floor** is at or above the BFE, as shown in Figure 6. If continuous walls are used below the BFE, they must be equipped with openings that allow flood waters to flow into and out of the area enclosed by the walls (Figure 6). Allowing the entry and exit of flood waters ensures that water pressures will be the same on both sides of the walls and reduces the likelihood that water pressure will cause the walls to fail.

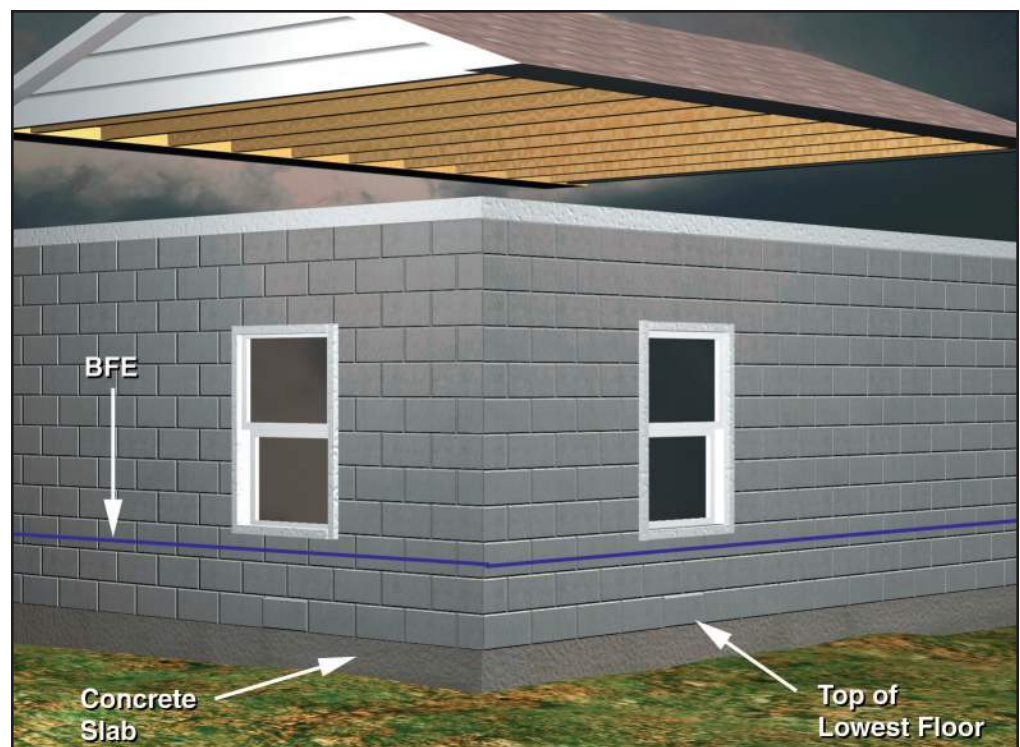
Figure 10
The first step in Technique 1 is removing the roof.

Technique 1 is appropriate for houses with concrete or masonry walls, but not for houses with other types of walls, such as those framed with wood studs, which would be more vulnerable to flood damage. This technique is usually appropriate when the depth of the base flood at the house is no more than 4 or 5 feet above grade. The elevation process begins with the temporary removal of the roof and roof framing, in a single piece if possible (Figure 10). This is commonly done with a crane. The roof is then stored on site so that it can be reinstalled later. The next step is to remove the windows and doors.

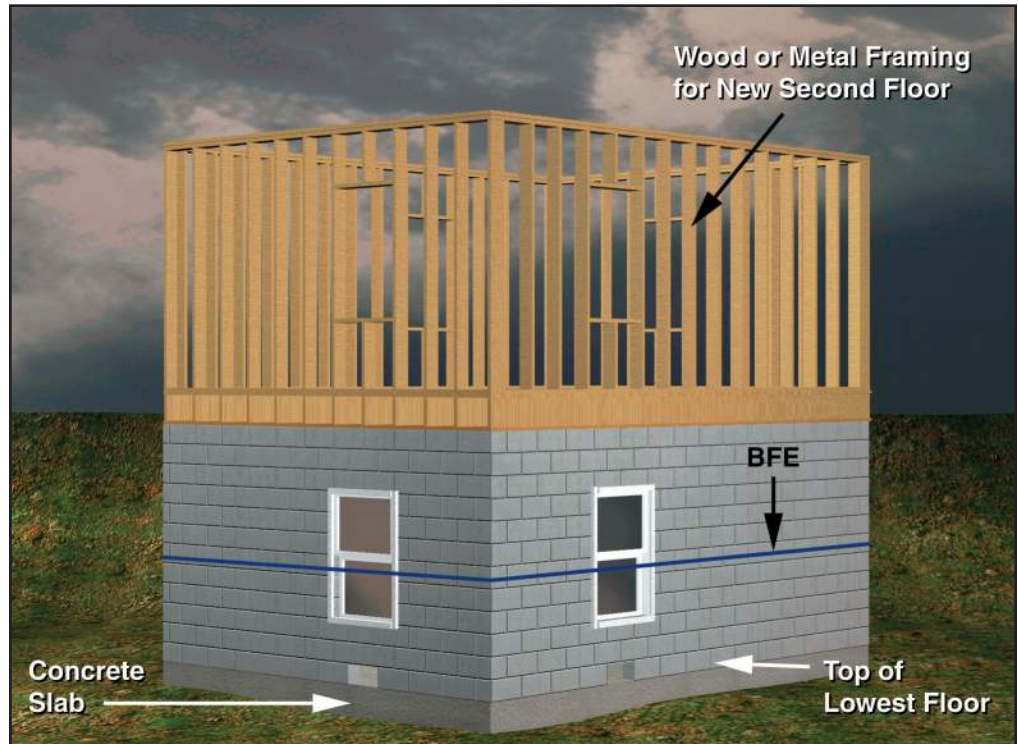
The new second-story floor and walls are built on top of the existing lower story.

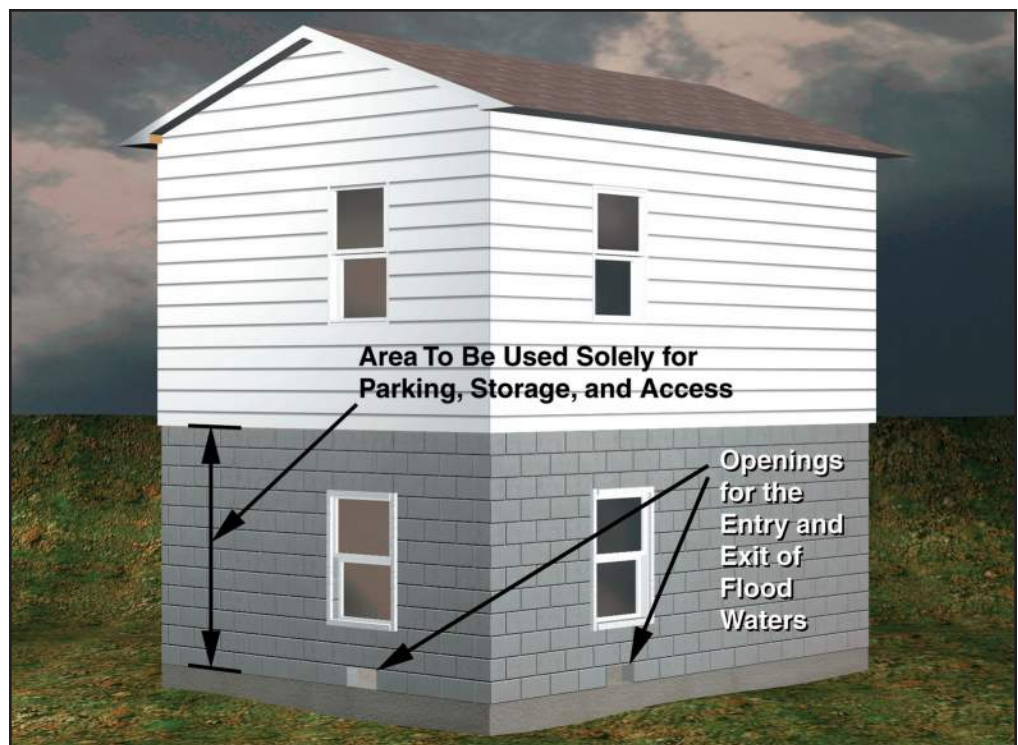
The new second-story walls are covered with siding or stucco.

Some homeowners prefer that the second story be constructed of masonry, but wood- or metal-framing is more common, primarily because it is lighter and less expensive. The roof is replaced, and blocks are removed from the walls to allow flood waters to enter and exit. Exterior sheathing is then added to the framed walls of the second story, the new windows are installed, and siding or stucco is applied to the sheathing (Figure 16).

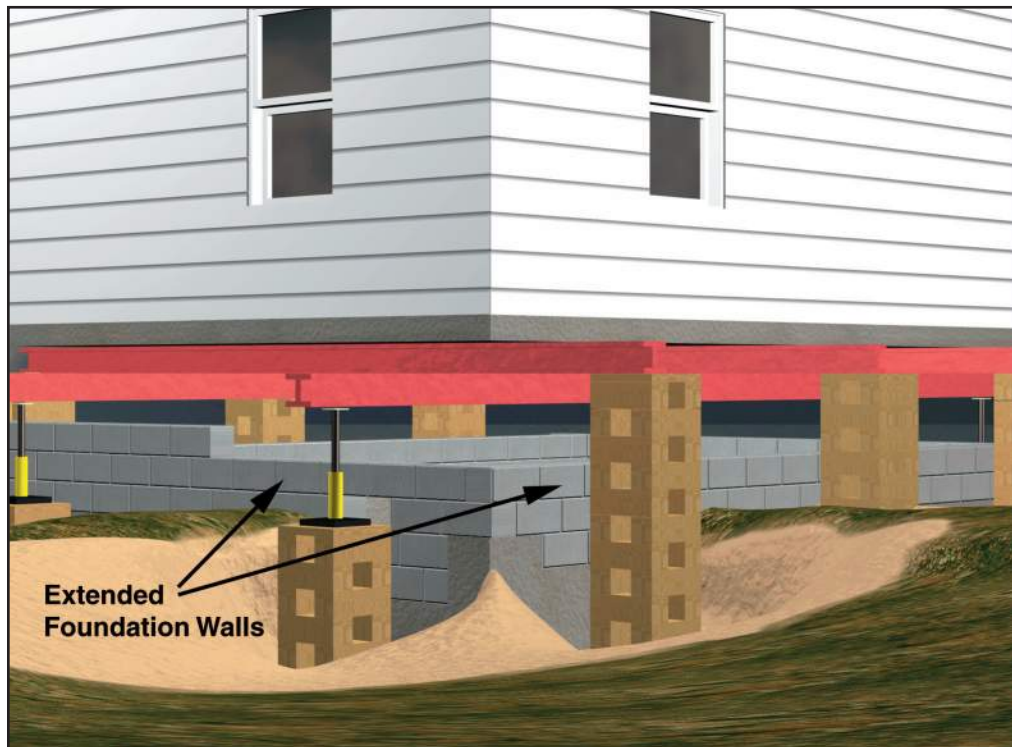
Figure 20
New, extended
foundation walls are
constructed with
concrete blocks.

This process is repeated until the house is raised to the desired height. The foundation walls are then extended upward with additional rows of concrete block (Figure 20). As in the previous techniques, openings are made in the walls within 1 foot of the ground so that flood waters will be able to flow into and out of the area below the elevated floor. The jacks and beams are removed, and the openings left around the beams are filled with blocks (Figure 21).

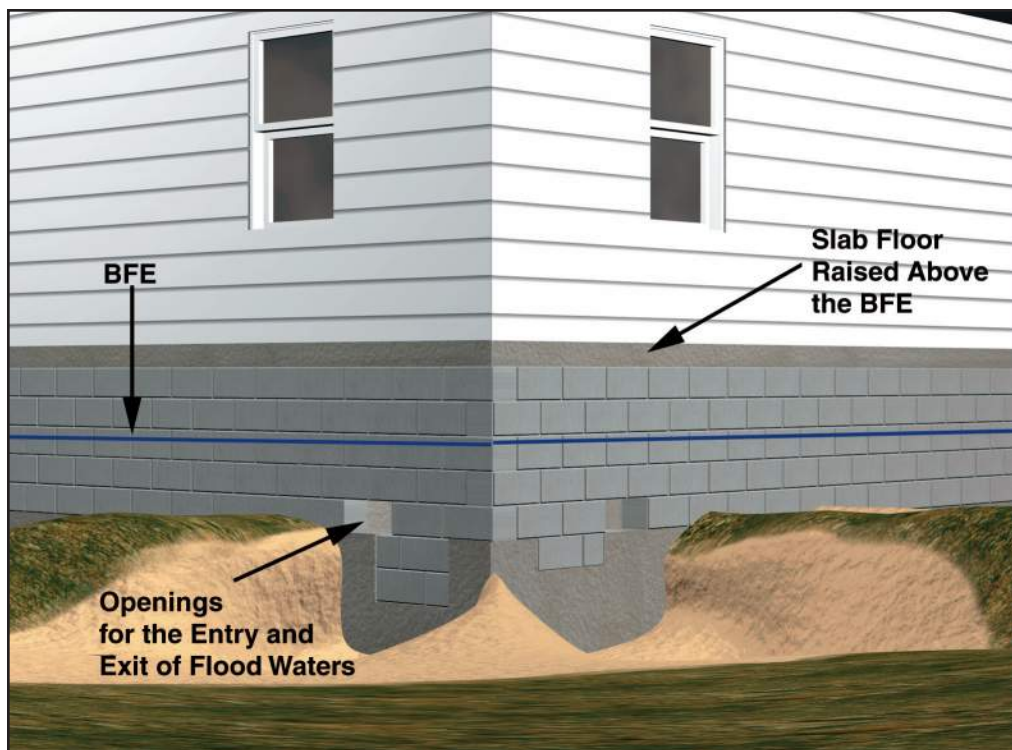
Figure 21
Elevated house and
slab on new, extended
foundation walls.

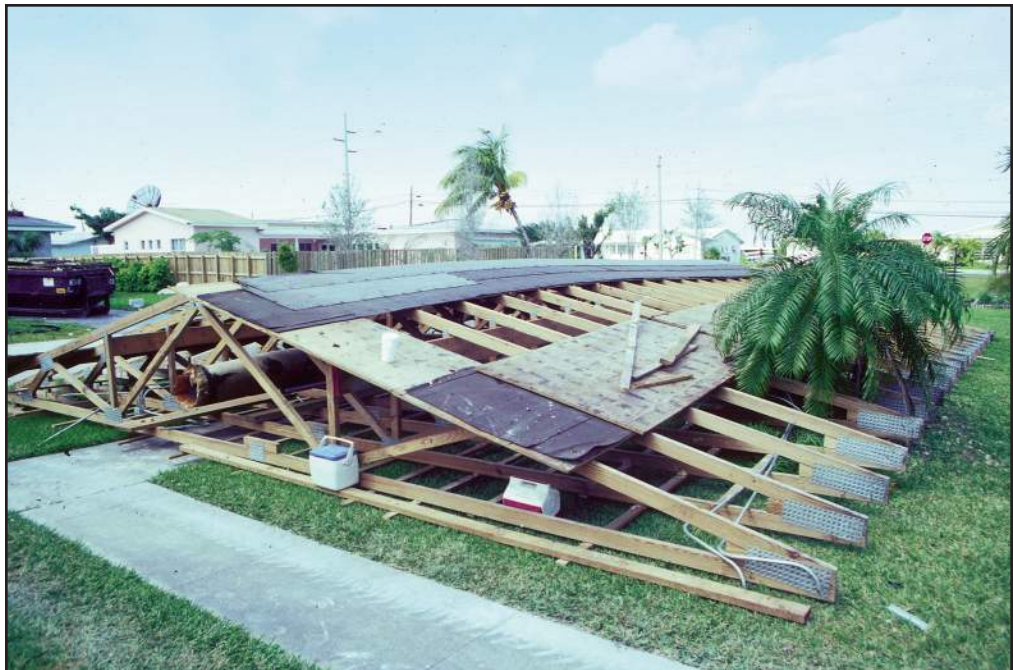
The roof of this house was removed as a single piece; the trusses were held together with bracing and portions of the original roof sheathing. This approach made it easier to reinstall the roof at the end of the project.

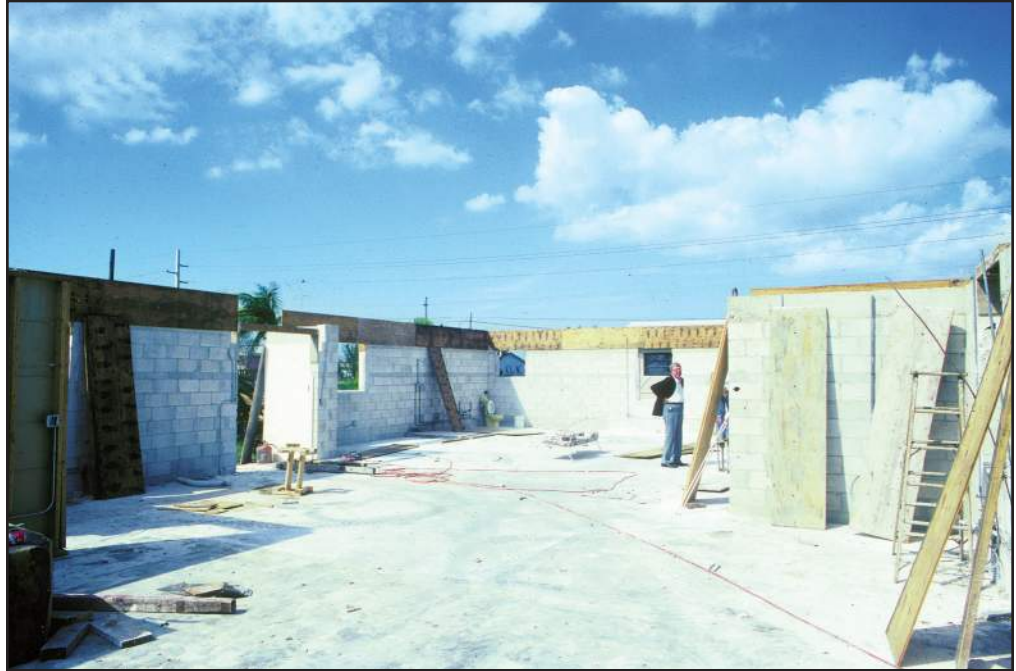
Figure 40

After the roof was removed and the storm-damaged interior gutted, the walls of the house were extended upward and a new bond beam added at the top.

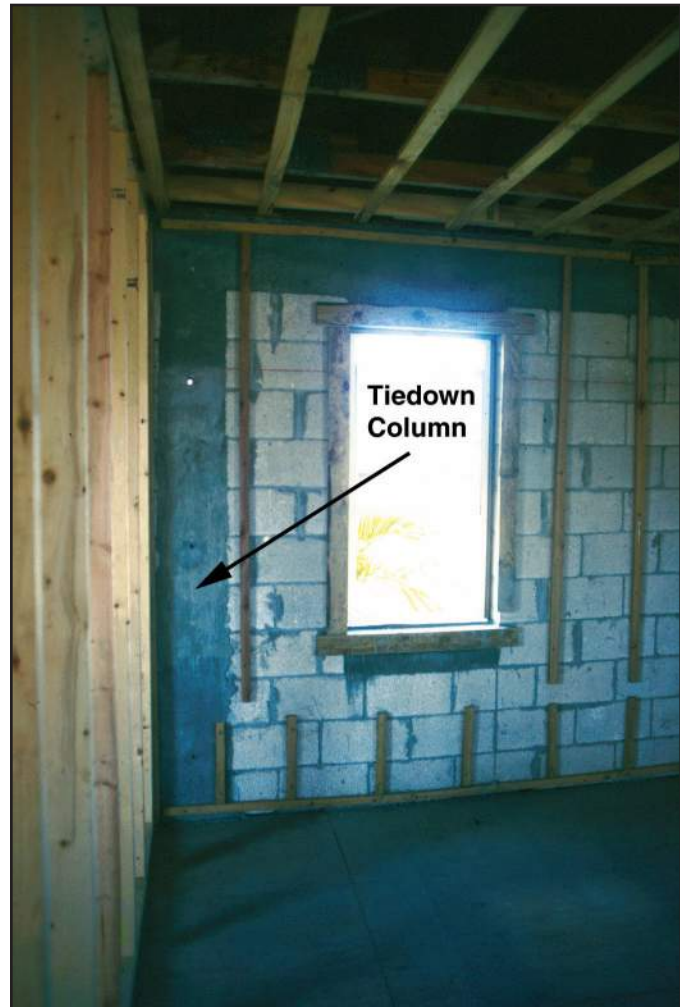
Figure 46
Concrete tiedown columns, such as the one to the left of the window in this photograph, were also used in this house.

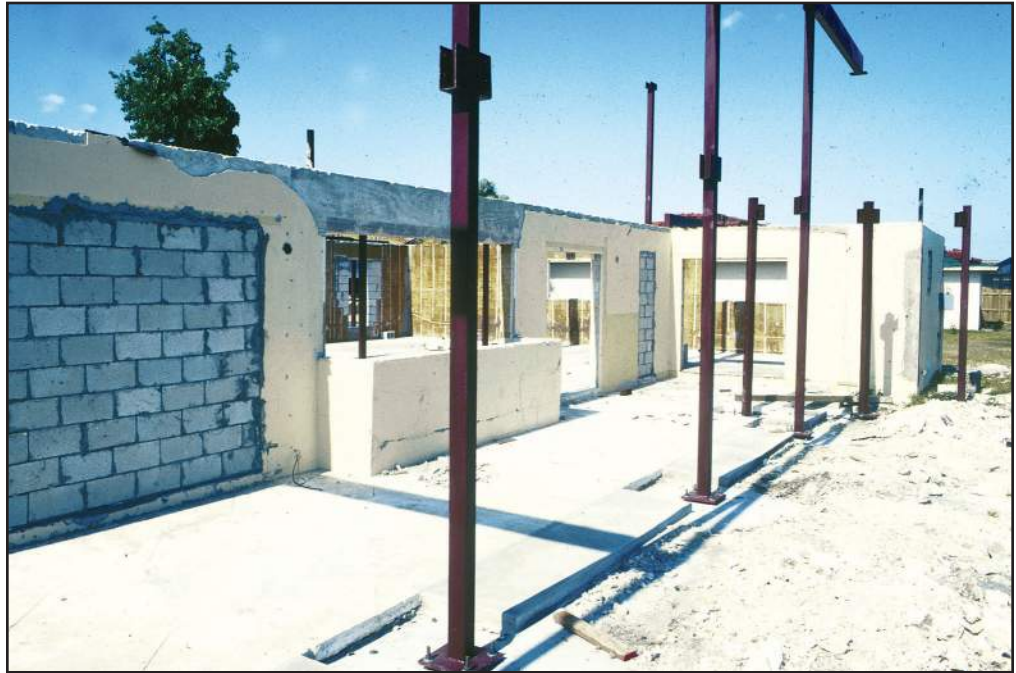
Figure 52

The existing first-story walls have been strengthened by the addition of concrete block. Metal columns and beams have been added to help support the new second story.
